DT/IT/MX/YZ 250, 360 & 400 Ignition System Tests & Fixes

Machines that have a black plastic pick-up in the generator centre & rotor stamped FOT02173 (74-76)

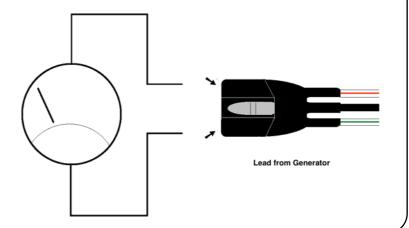
Test 4 - High speed source coil

White/green to white/red 100 ohms. A 5% tolerance applies. Any reading 95 ohms or less at 20 degrees C (70F) shows a failure
