CDi Ignition Problems

Why the new CDi unit has not fixed the problem, seems to be causing other problems or appears not to work.

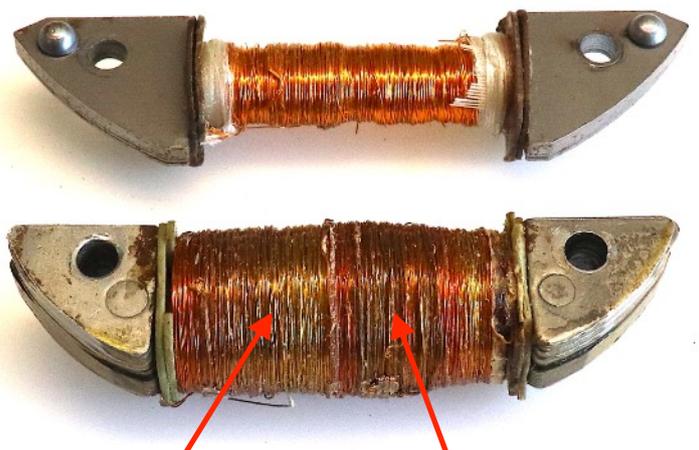
With the outer layer removed it is possible to see copper windings. The top winding is in good condition, the bright copper will darken with use and age but will remain uniform in colour.

The lower winding, shows a range of colours from copper at each end, an area that looks greenish in the photo but is actually much lighter due to getting too hot, and also a dark patch of failed, shorted insulation. This damage is the weak area causing the problem, it will spread until the winding fails completely. The winding resistance was only 10% off tolerance but the bike would not start hot, or run with a new CDi unit fitted. Once this winding was replaced the bike ran perfectly on its new CDi unit.

Insulation starting to fail

Darker area shows failed & shorted windings
