Rex's Speed Shop

AM1 CDi Unit for SST175/250

Our replacement CDi unit for the Harley Davidson SST175/250 models (Originally Aermacchi, later to become Cagiva) has internal electronics designed to exactly match the electronics of the original unit.

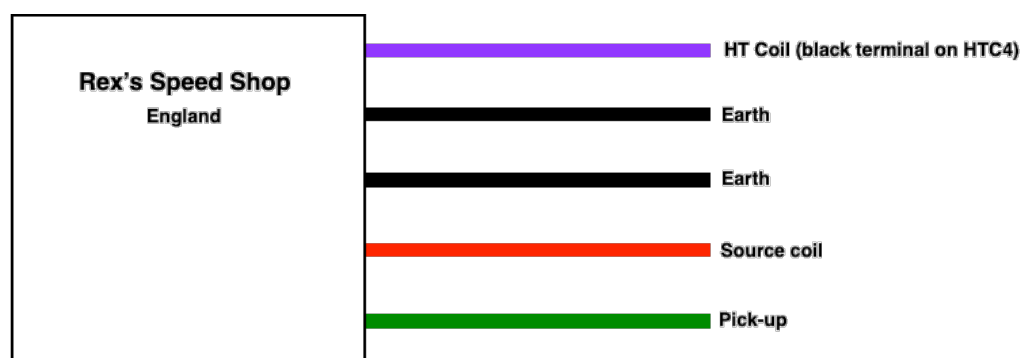
AM1 Connections

To keep installation simple the wires on our new CDi unit match the bike's. Simply match up the wire colours and plug in.
