Lighting and Charging Coil Variations

Charge & Lighting Coil Combinations

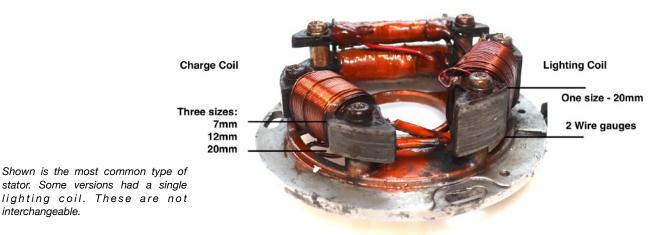
Best information to date: Coil Compatibility Guide				
Charge Coil Thickness	Charging OEM	Charge Coil P/N	Lighting coil P/N	Lighting OEM
7mm	32130-29612	LC-9 →	LC-12	32120-29612
12mm	32130-30511	LC-10 →	LC-12	32120-29612
20mm	32120-29611	LC-11 →	LC-13	32130-29611
12 Volt conversion	Not yet available

The CDi source coil assembly is always the same, however when replacing lighting and charge coils you must pay close attention to the thickness of the iron core and position on the stator plate of each winding. Make drawings and take pictures, carefully note dimensions and positions of coils and wire routing. We charge our normal hourly rates to talk you through fitting parts.

The most common configuration is for a separate lighting and charge coils however some bikes, for example TS250 K models, have a single lighting coil (932120-30020). We offer a repair service for this combined lighting and charge coil.

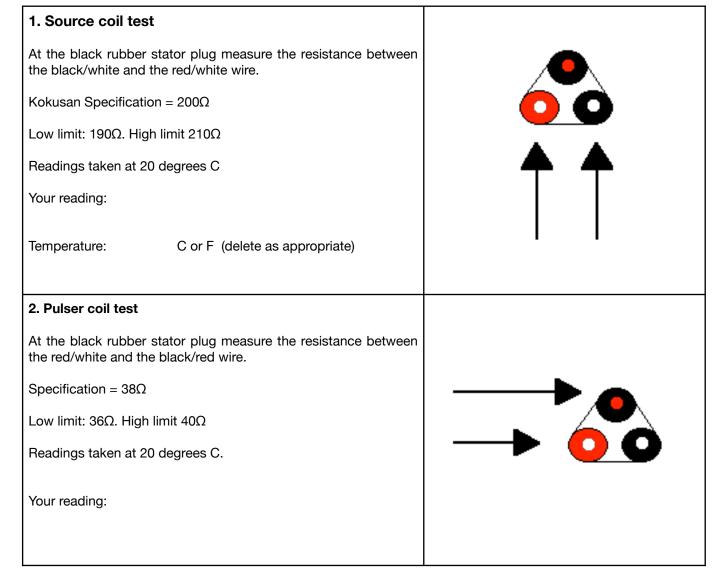
Checking CDi source coil resistance

The CDi source winding are a very hard working part, they run at over 200 volts and so the insulation on the fine wire in the windings is under a heavy load all the time the engine is running. As insulation ages it becomes weak allowing power to seep away from the CDi box. It is the random way old windings break down that causes a range of confusing symptoms.
